FLIGHT TEST-WHIRLING ARM CORRELATION OF RAIN EROSION RESISTANCE OF MATERIALS

TECHNICAL REPORT AFML-TR-67-420

SEPTEMBER 1968

AIR FORCE MATERIALS LABORATORY
AIR FORCE SYSTEMS COMMAND
WRIGHT-PATTERSON AIR FORCE BASE, OHIO

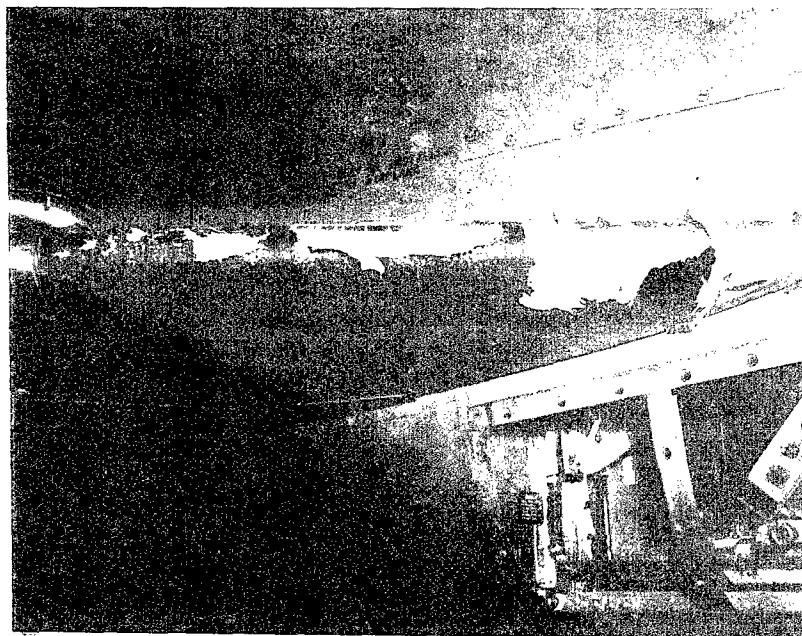
Figure 67. Surface of Deicing Boot on Lower Surface of Right Wing Leading Edge Not Damaged as Much as the Section on Top of Wing

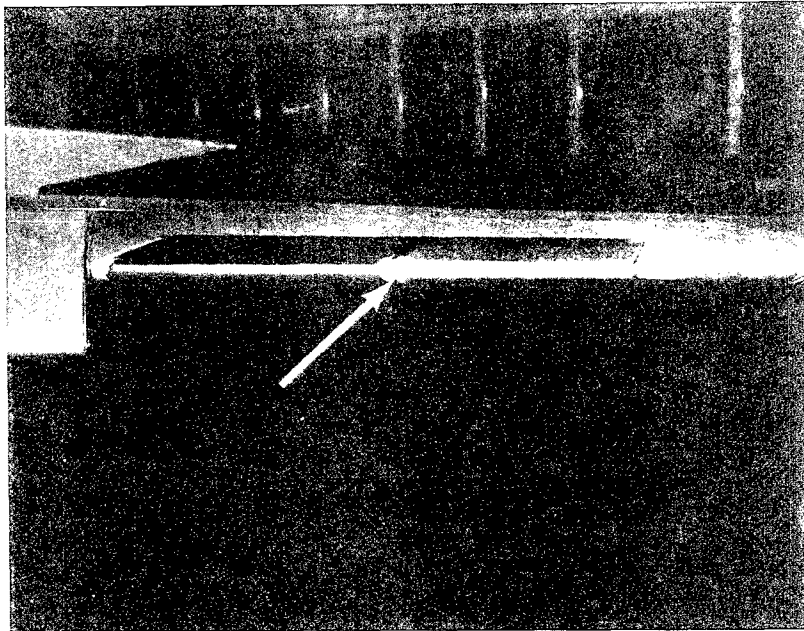
Figure 68. Goodrich Samples 1 and 2 on Left Wing Tip Show Little Adverse Effect After Flight 16; the Arrow Indicates Slight Damage to Inboard Edge of Sample 1

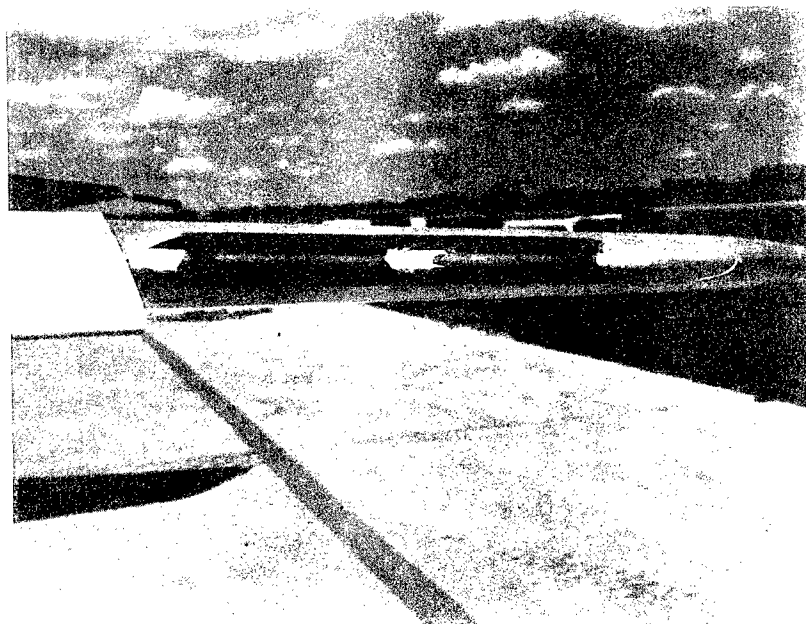
Figure 69. Final Damage Received by Goodrich Samples on Left Wing Tip

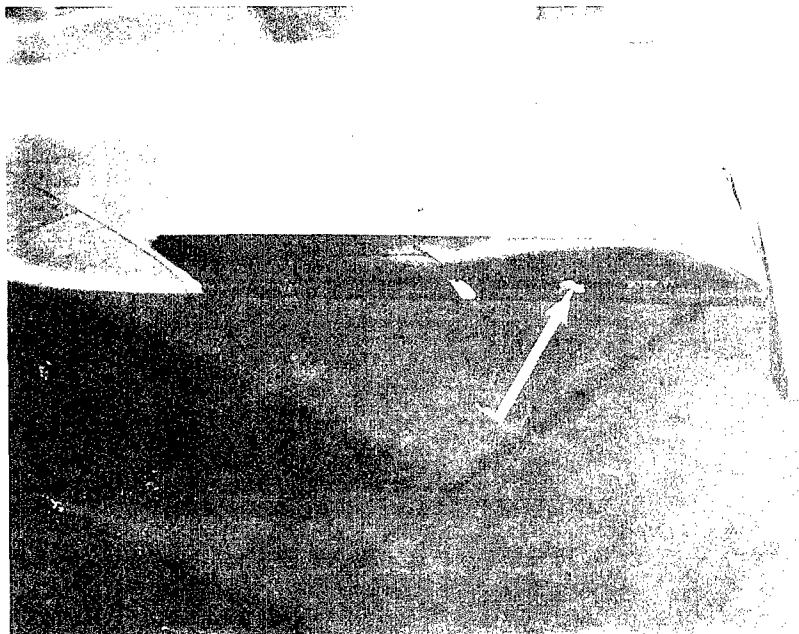
This shoe received the first visible damage as a result of Flight 7 (Figure 70) when it was cut along the leading edge. Inspection after Flight 10 showed the

Figure 70. Goodrich Samples 3 and 4 on Leading Edge of Right Wing Received Damage During Flight 7; the Arrow Points to a Cut on Leading Edge in Sample 3

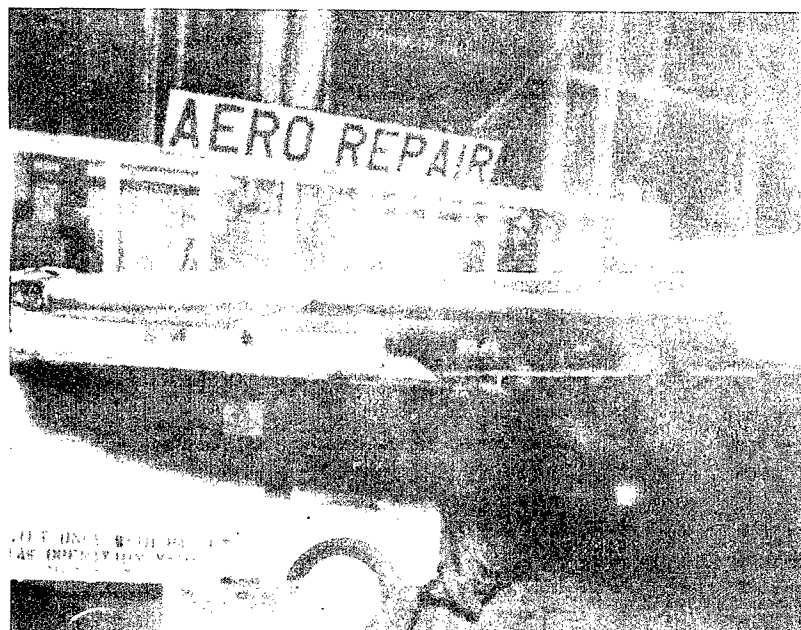
Figure 71. Inboard Sample on Right Wing Tip With Torn Leading Edge After Flight 13

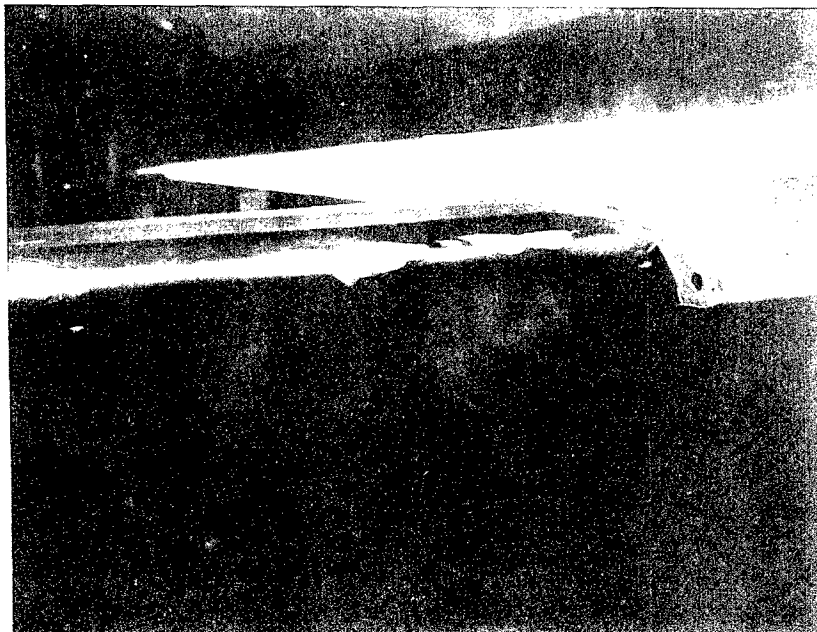
Figure 72. Samples 3 and 4 on Right Wing Tip After Flight 16

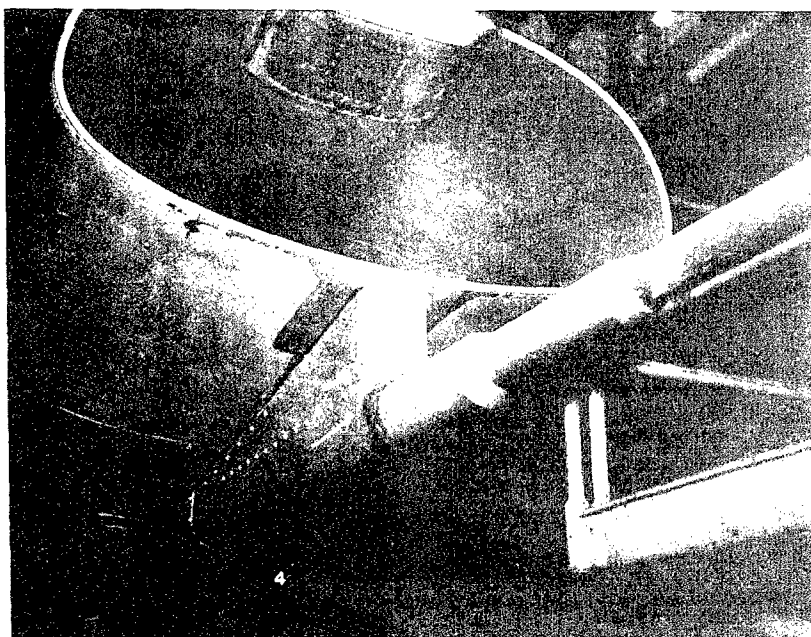
Figure 74. Damage to Goodrich Sample on Noseboom Mount During Three Flights
